Briefing on Bay Bridge Bolts - May 29, 2013

1. What caused the E2 anchor bolts manufactured in 2008 to fail?

Metallurgical Report on 2008 Bolts, Dated May 7, 2013

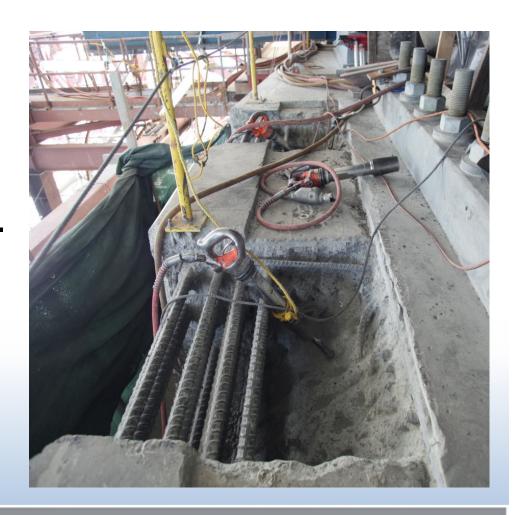
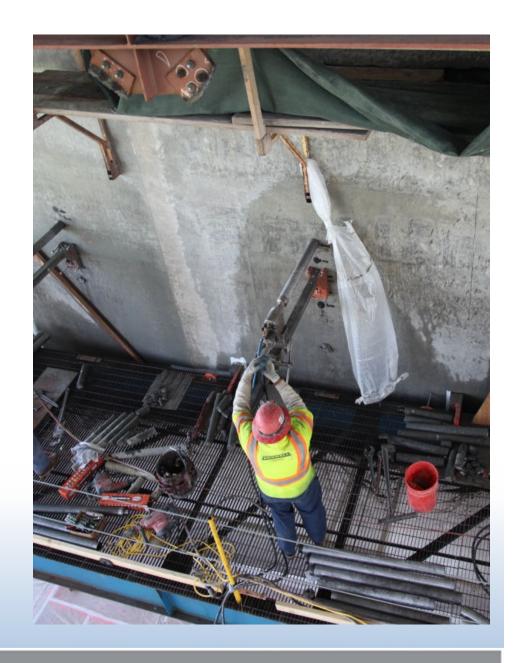
Construction Progress on Retrofit

- Design moving to shop drawing phase.
- Concrete removal and coring of E2 has begun.
- Material procurement ongoing.

- Fabricator is XKT Engineering, Inc.
- Work will be done locally (Mare Island)
- Schedule of Retrofit Completion Being Finalized

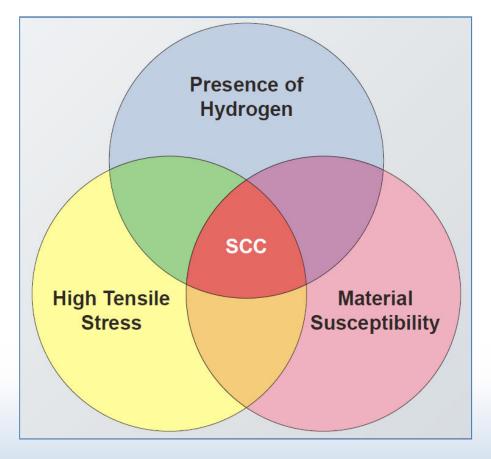
Stress Corrosion

- Based on regular inspection and ongoing testing, remaining bolts continue to perform as designed.
- Longer term concern is whether remaining bolts under high tension might be subject to stress corrosion cracking.
- Long term stress corrosion susceptibility is a function of the size and hardness of material, and level of tensioning.

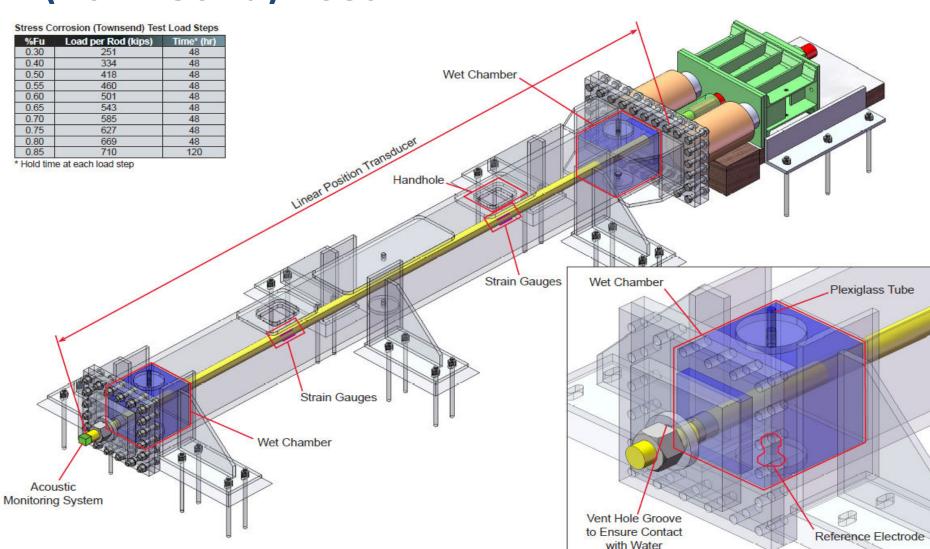
Test Set-up for Stress Corrosion (Townsend) Test

- The Townsend test is an accelerated test being prepared to determine the longer term susceptibility of the material to stress corrosion.
- Full sized bolts will be soaked in a controlled concentrated salt solution while tensioned progressively over a number of days until failure.
